DEPARTMENT OF TRANSPORTATION

Contract #: 04-0120F4Cty: SF/ALA Rte: 80 PM: 13.2/13.9File #: 69.28**WELDING INSPECTION REPORT****Resident Engineer:**Pursell, Gary**Address:** 333 Burma Road**City:** Oakland, CA 94607**Report No:** WIR-001398**Date Inspected:** 06-Feb-2008**Project Name:** SAS Superstructure**OSM Arrival Time:** 730**Prime Contractor:** American Bridge/Fluor Enterprises, a JV**OSM Departure Time:** 1230**Contractor:** Zhenhua Port Machinery Company, Ltd (ZPMC), Changxing Island **Location:** Shanghai, China**CWI Name:** Fu Yu Hong**CWI Present:** Yes No**Inspected CWI report:** Yes No N/A**Rod Oven in Use:** Yes No N/A**Electrode to specification:** Yes No N/A**Weld Procedures Followed:** Yes No N/A**Qualified Welders:** Yes No N/A**Verified Joint Fit-up:** Yes No N/A**Approved Drawings:** Yes No N/A**Approved WPS:** Yes No N/A**Delayed / Cancelled:** Yes No N/A**Bridge No:** 34-0006**Component:** Tower Mock-up**Summary of Items Observed:**

Tower Shop (Tower Mock-up 77 M)

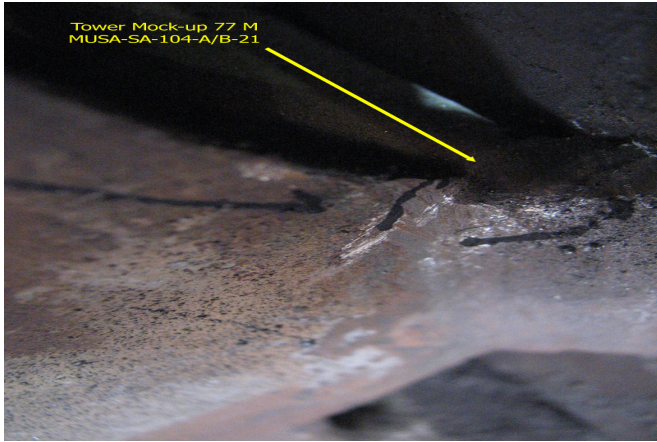
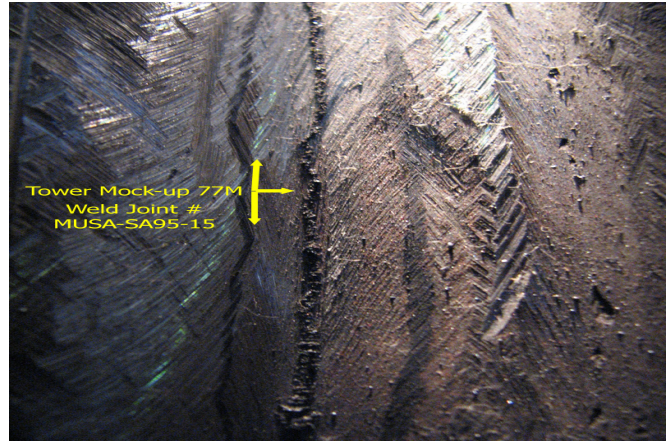
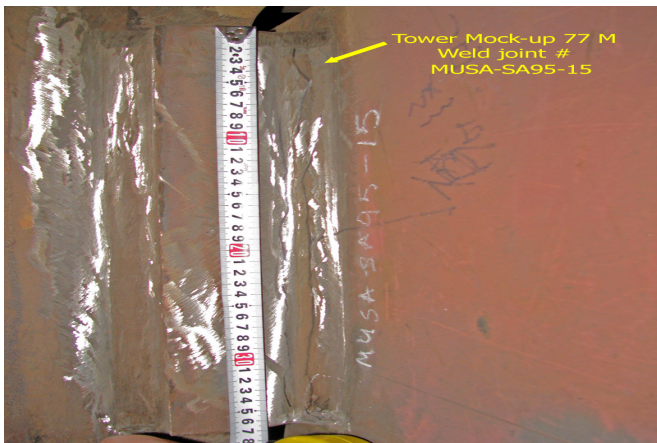
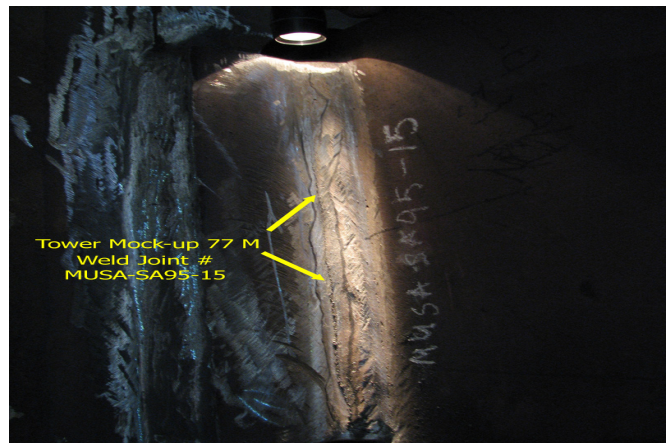
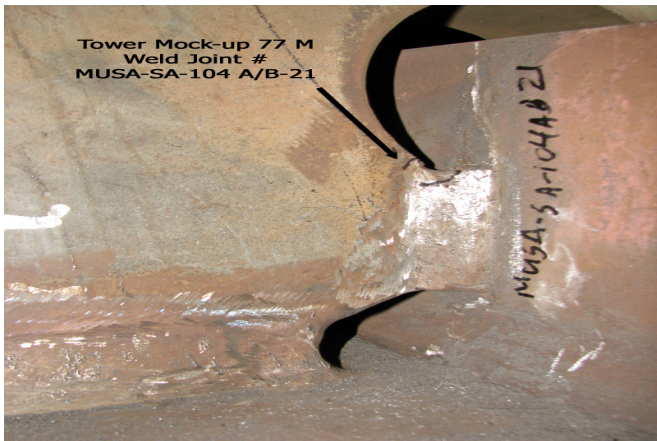
The QA inspector recorded two cracks located at the Tower Mock-up 77 M segment. The cracks were located at joint MUSA-SA-95-15(found by the Contractor)and MUSA-SA-104-A/B-21 (found by Caltrans QA

located at the top section of the weld joint MUSA-SA-104-A/B-21. The QA inspector had a conversation with

crack was found by Caltrans representatives at the junction of the joint # MUSA-SA-104-A/B-21. ZPMC

identified by ZPMC and Caltrans with cracks on the welds.
